# Test Report

Report No. A2260054344101

Sample Name Floor heating module  
Model No. LS300  
Sample Received Date Jan. 19, 2026  
Testing Period Jan. 19, 2026-Jan. 27, 2026

| No. | Test Item |
|---|---|
| 1 | IPX6 |

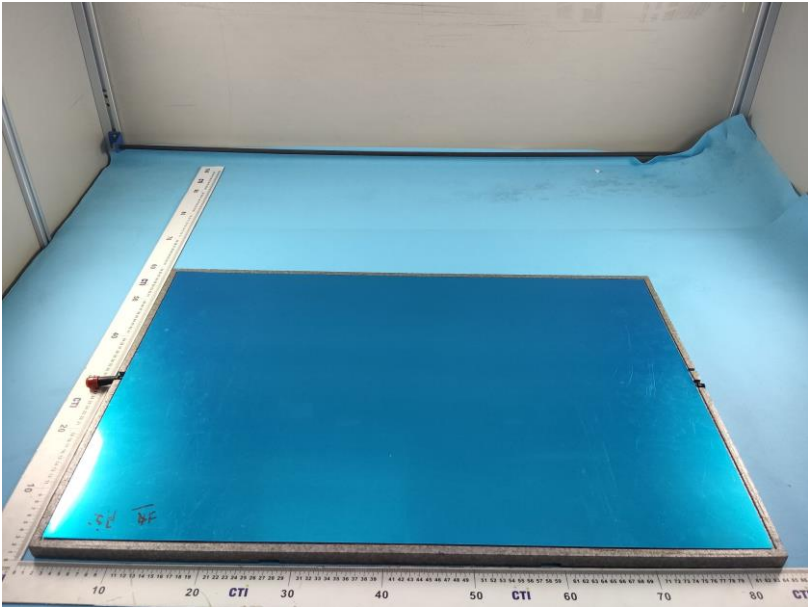
A2260054344101001

Sample Photo(s)

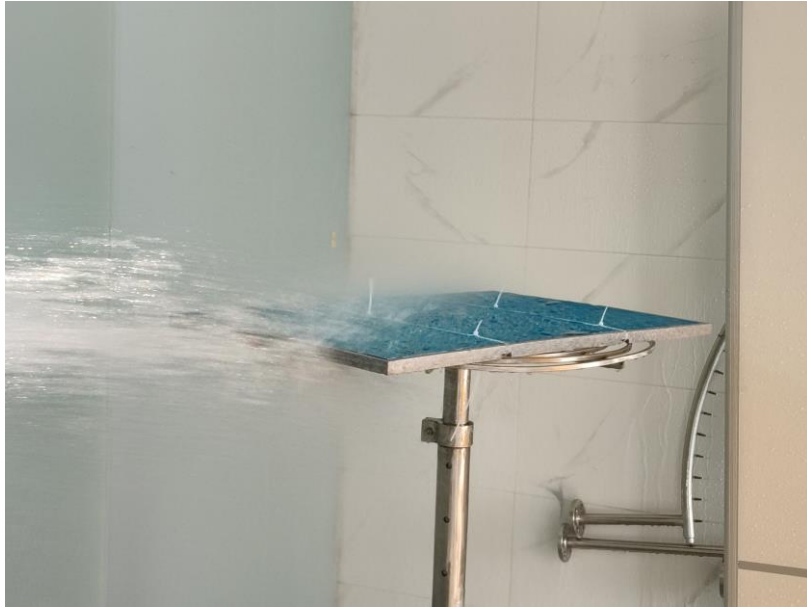
A2260054344101001

- a) Water flow rate: 100L/min
- b) Distance from sample surface to nozzle: 2.5~3m
- c) Diameter of the nozzle: 12.5mm
- d) The rotation speed of the turntable: 1r/min
- e) Test duration: 3 min

**Test Photo(s)**

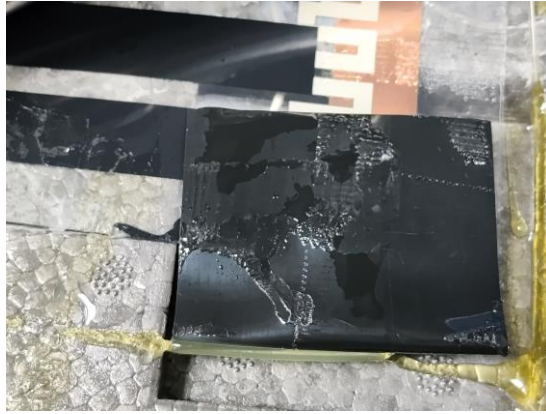
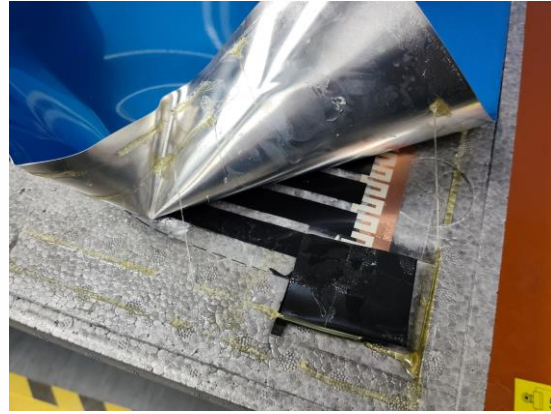
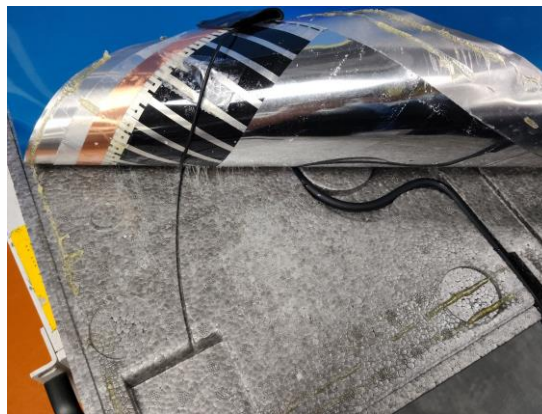
| Sample No. | Criterion | Test results (visual inspection) | Conclusion |
|---|---|---|---|
| A2260054344101001 | After the experiment, there should be no water ingress inside the sample casing. When a small amount of water seeps into the inner edge of the product along the outer layer of the wire harness, the product functions normally. | After the experiment, there was a small amount of water ingress at the edge of the sample, but the function was normal | Pass |

**Sample Photo(s) after the test**
